EPBC Act Annual Compliance Report 2023

Isaac Downs – EPBC Act Referral 2019/8413

Stanmore IP South Pty Ltd

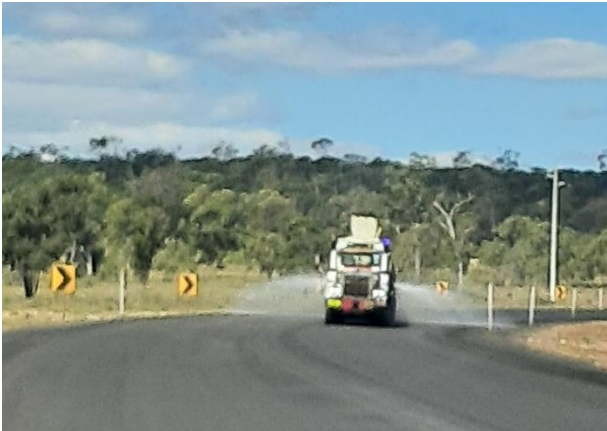
Observed Location	Field Images
Dust Suppression

A photograph showing a white truck driving away on a paved road. The truck is equipped with a water sprayer system that is actively spraying water onto the road surface, creating a mist. The background features a line of trees and a clear blue sky with some light clouds. The road is flanked by yellow directional signs and a utility pole.

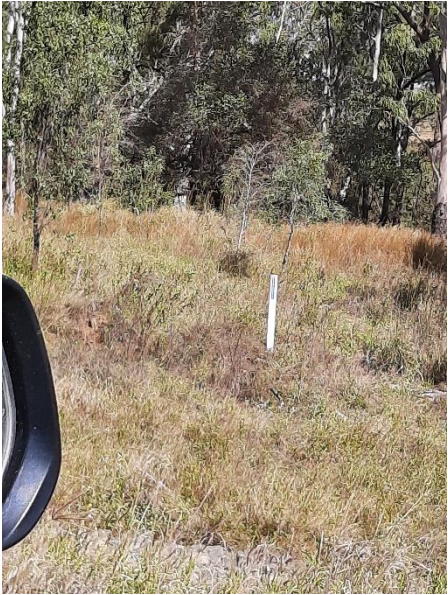
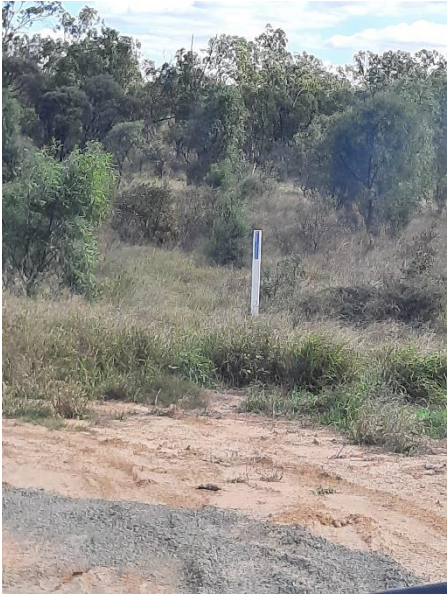
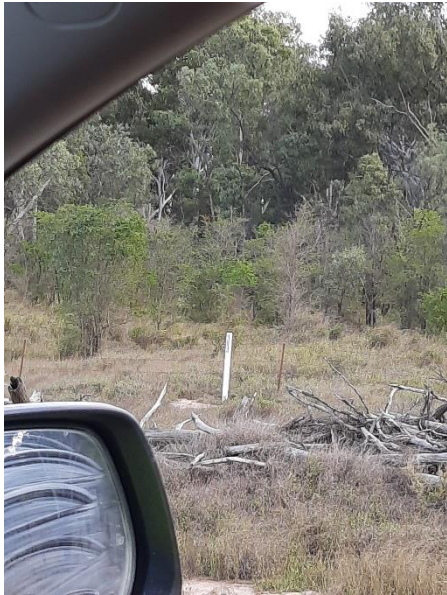
Observed Location	Field Images		
Approved Limit of disturbance markers and fences

Condition Number	Condition	Findings	Compliance Status
Conditions specific to the action			
Maximum Impact Limits			
1	The approval holder must not impact beyond the limits of the Project area	<p>During the site visit, limits of disturbance markers were observed. Mine plans, the EPBC approval permit, the disturbance footprint and permits to disturb were reviewed, and disturbance beyond authorised limits was identified as having occurred.</p> <p>The previous compliance report (2021/ 2022) identified areas of disturbance beyond the EPBC approval boundary and a non compliance was found with condition 1 as a result. The non compliance was reported to the regulator and investigated, and the matter resolved during the period of this compliance report.</p> <p>Review of the non compliant disturbance areas and subsequent correspondence between Stanmore and the regulator was undertaken in conjunction with review of up to date disturbance spatial files.</p> <p>Two areas of mapped disturbance that were not identified in the previous compliance report or associated correspondence were identified outside the EPBC boundary, including:</p> <ol style="list-style-type: none"> 1. An area of approximately 0.2 ha associated with levee armour rock on the outside batter of the flood levee was identified outside the approval boundary. The disturbance occurred during the 	NC
